Field Investigation of Face Spall in Moderate Strength Coal Seam at Vang Danh Coal Mine, Vietnam

Le Tien Dung^{1,*}, Dao Hong Quang²

Abstract: Face spall in moderate strength coal seam occurs less frequently but can be more severe and takes a longer time to remedy compared to face spall in the weak coal seam. This paper presents a field investigation of face spall in moderate strength coal seam at Face I-8-1, Vang Danh coal mine, Quang Ninh coal field, Vietnam. The leg pressure of shield support and face condition were monitored within two months, and on-site remedial measures to the spall were discussed. The monitoring results confirmed that the front and rear leg pressure profiles are consistent with world-wide observations. The coal face condition in actual operation was found to be more stable than that in project design. The face spall occurred along face dip direction, but mostly in small extent of less than 0.5 m deep and during transitional time between working shifts. Proper ground control near gate ends by using higher capacity shield supports and supplemental hydraulic props was identified to improve face stability in the area. On-site remedial measures proved their ef

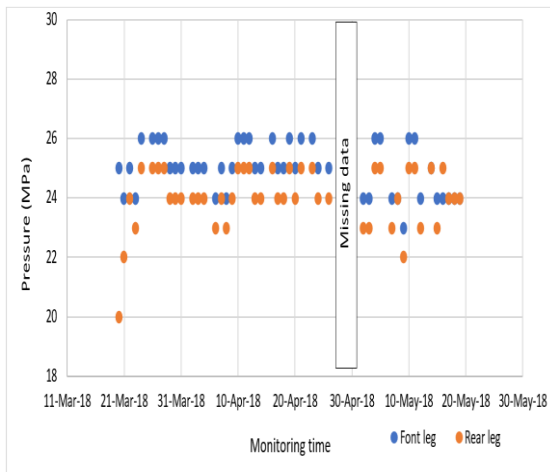
The front leg and rear leg pressures of Shield #1 near the tailgate, Shield #30 in the middle of face length in dip direction, and Shield #60 near maingate were plotted in Figures 5-7. It is apparent that during the period of monitoring, the recorded pressure at all face positions fluctuated around 25 MPa. This value was equal to 79.4% of the designed working pressure (31.5 MPa) and was only 71.43% of the yield pressure (35 MPa). The difference in working pressure was related to the practical coal seam roof strata, which were stronger than evaluated. Another reason was that if the pressure in the leg was as high as designed, the available hydraulic system such as pump station, cable, hose, or safety valve could stop working or be broken.

Figure 5. Pressure in front leg and rear leg of Shield #1 near tailgate.

It was also observed in three monitoring positions that front leg pressure was mostly greater than rear leg pressure. This is because toward the rear of the shield support, top coal was largely broken and thus its loading capacity was reduced. Toward the front of shield, top coal and roof strata were less broken that could transmit loading from overburden strata onto the shield canopy. The current monitoring is consistent with world-wide observations. For instance, Cai et al. [16] reported that the loading ratio of front legs to rear legs from 41 longwall

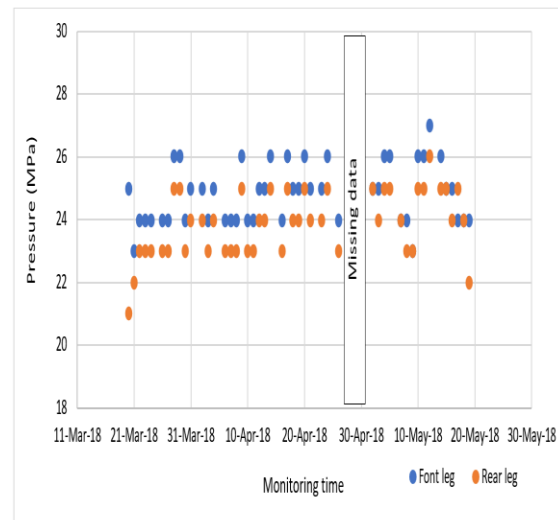
Figure 6. Pressure in front leg and rear leg of Shield #60 near maingate.

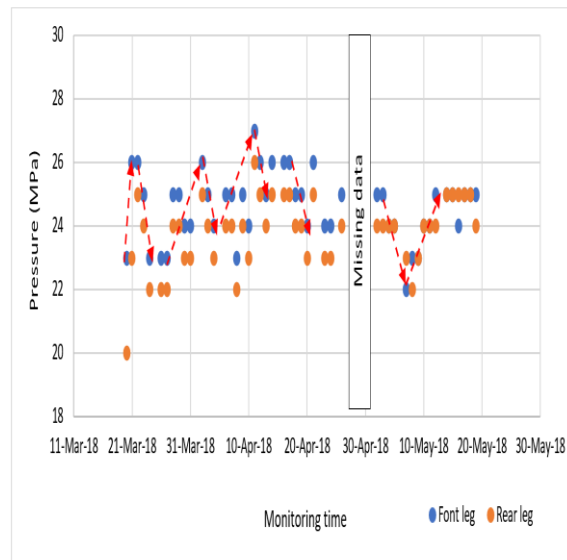
Figure 7. Pressure in front leg and rear leg of Shield #30 in the middle of face length in dip direction.

During the time of monitoring, coal face was, in general, stable. Remarkable spalls were observed near two gate ends on 2-12 May 2018. Other significant spalls occurred locally in the middle of face length in dip direction on 28-31 March and 17-20 April 2018. These spalls occurred to a small extent, which were seen less than 0.5 m deep into upper face line and top coal section. This stable face condition was mainly driven by the moderate coal strength and strong rocks constituting the seam. On the other hand, the spalls happened in short periods, mainly in transitional time between working shifts. This is understandable since the face was exposed for a longer time before a next mining cycle, which was implemented in next shift. The two profiles near gate ends followed a similar trend in which the front and rear leg pressures tended to be unchanged during 2-3 days before reaching a new stable value. Meanwhile, the profile in the middle of face length was different-the front leg pressure repeatedly went up to a peak value of approximately 26 MPa before went down to low value of 22-23 MPa (see red arrows in Figure 7). This can be explained by the fact that while the shields completely inside the face were advanced after every shearer cut, the shields near gate ends were in use for a longer time before were moved to next position. Additionally, the areas near gate ends, as in high stress concentration conditions, were further supported by hydraulic props that ensure their stability.

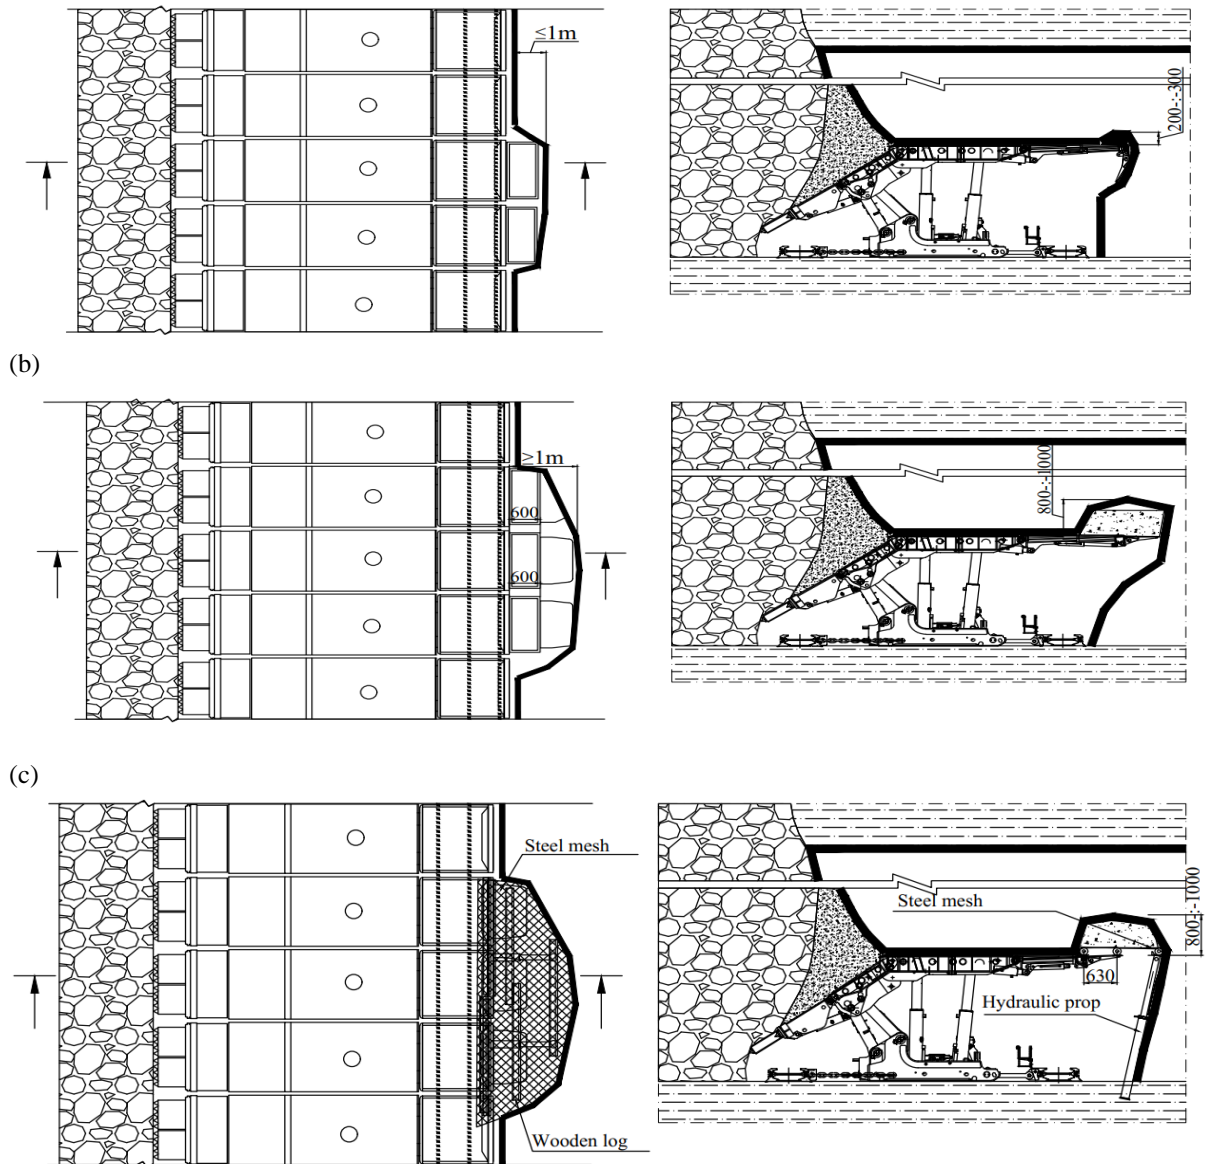
Figure 9. Using a) extended canopy; b) Extended canopy + shield guard; c) Steel mesh + hydraulic prop + wooden log to cover cavity [15].

To remedy face spall incidents, Vang Danh coal mine has developed several technical measures as follows. In cases where the spall depth into coal face is less than 1 m, the extended canopy of shield support is sufficient to cover the roof cavity (Figure 9a). When the spall depth is greater than 1 m, both extended canopy and shield guard are used to increase the cover length for the cavity (Figure 9b). When the spall is more serious (e.g., deeper than 2 m into coal face), steel mesh, hydraulic prop and wooden log are combined for remedy (Figure 9c). That is, hydraulic props act as additional pillars while steel mesh and wooden logs play as a protective plate. These measures, in essence, aim to preventing broken roof coal and coal wall from interrupting normal operation of shield support. Their application was proved to be efficient at the site in where the spall was from small to moderate extent. In the same spall extent range, the measures have also been applied successfully at other Quang Ninh longwall coal faces such as Ha Lam [20] and Quang Hanh [21] coal mines. Although the above measures are flexible, easy, quick and cheap to perform at different face

locations, they require manual labour that increases unsafe and health issues at work. Furthermore, when main roof strata rupture, associated face spall can occur in large extent and magnitude [22]. In such a case, Vang Danh coal company has increased face advance rate and/or injected reinforced chemical to quickly pass through unstable areas. The solutions aim to
