Field Investigation of Face Spall in Moderate Strength Coal Seam at Vang Danh Coal Mine, Vietnam

Le Tien Dung^{1,*}, Dao Hong Quang²

Abstract: Face spall in moderate strength coal seam occurs less frequently but can be more severe and takes a longer time to remedy compared to face spall in the weak coal seam. This paper presents a field investigation of face spall in moderate strength coal seam at Face I-8-1, Vang Danh coal mine, Quang Ninh coal field, Vietnam. The leg pressure of shield support and face condition were monitored within two months, and on-site remedial measures to the spall were discussed. The monitoring results confirmed that the front and rear leg pressure profiles are consistent with world-wide observations. The coal face condition in actual operation was found to be more stable than that in project design. The face spall occurred along face dip direction, but mostly in small extent of less than 0.5 m deep and during transitional time between working shifts. Proper ground control near gate ends by using higher capacity shield supports and supplemental hydraulic props was identified to improve face stability in the area. On-site remedial measures proved their ef

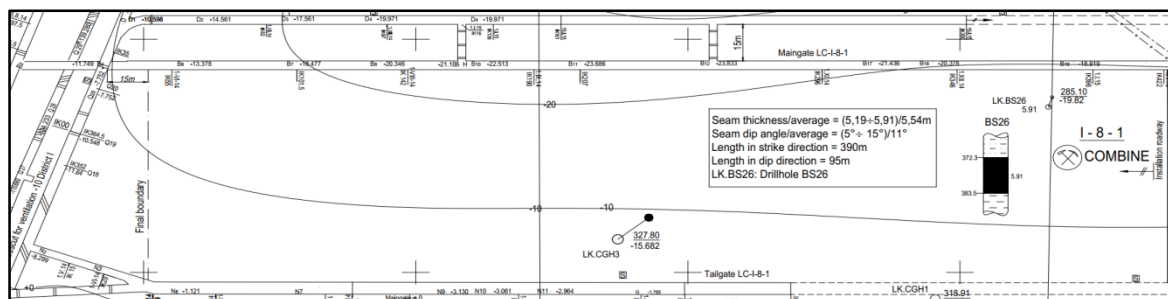
Face I-8-1 has a seam thickness of 5.19-5.91 m with an average of 5.54 m. The seam structure is simple with 0-2 rock band layers in average thickness of 0.24 m. The seam dip angle is in range of 5-15 degrees and its average is 11 degrees. The immediate roof has a thickness of 18.5-25 m and an average of 21 m. According to the assessment of Vinacomin Institute of Mining Science and Technology [14], the immediate roof thickness that directly affects shield support is 14.5 m above the coal seam. They are siltstone with a strength of 468.12 kG/cm². The main roof has a thickness 9.3-14.3 m and an average of 11.3 m. It mainly consists of sandstone and has a strength of 718.38 kG/cm². The immediate floor is similar to immediate roof in constituent, but its strength is slightly weaker, which is 298.66 kG/cm². The face is designed 380 m in strike direction, 93 m in dip direction and 300 m below surface. The development roadways are shown in Figure 3. The properties of major rock types at the mine site are given in Table 1 [14].

Figure 3. Layout of Face I-8-1 [14].

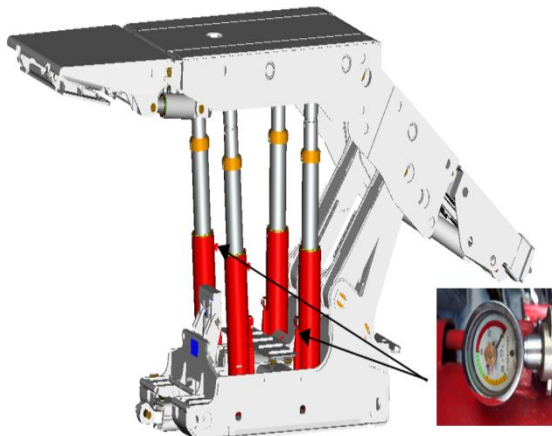
Figure 4. Shield support ZF4400 and pressure gauge [15].

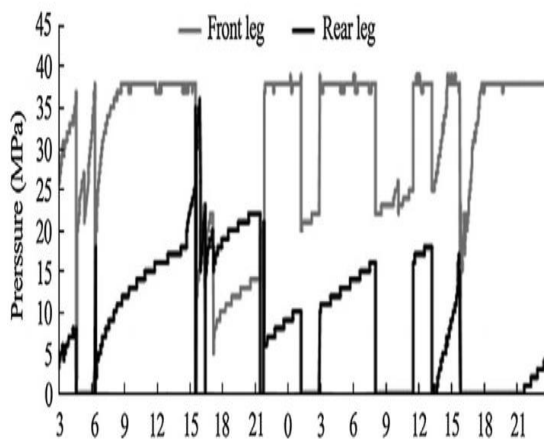
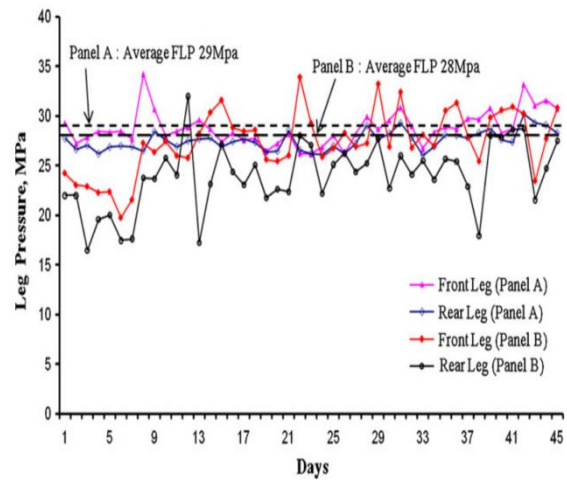
faces in China mostly ranged from 1.05 to 1.94. Yun et al. [17] clearly showed that the front leg pressure was greater than the rear leg pressure in another China longwall face (Figure 8a). The difference between front leg and rear leg pressures was also seen in India's longwall panels, as reported by Verma and Deb [18] (Figure 8b) and Singh and Singh [19].

Figure 8. Front leg and rear leg pressures monitored at (a) China [17] and (b) India longwall panels [18].
